IDENTIFICATION, CLASSIFICATION AND RANKING OF THE CAUSES OF BUILDING COLLAPSE IN ABUJA, NIGERIA – A REVIEW

D.O. Akuboh^{1*} and T. Aimola¹

¹Department of Civil Engineering, African University of Science and Technology, Abuja, F.C.T.

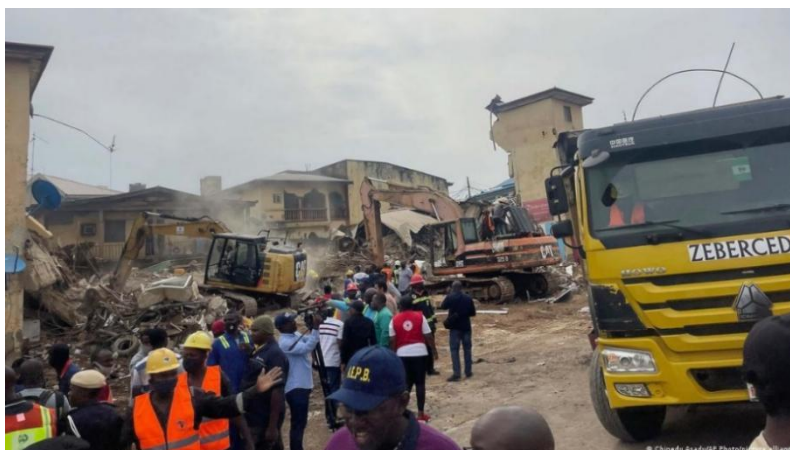
Plate 1: Two Storey Building Collapse in Garki Village, Abuja – 24th August, 2023.

21	2-Storey Building Under Construction	Abdullahi Hamza Road, Beside Freedom in Christ Mission, Close to Aso Savings and Loans Junction, Kubwa, Abuja	26th August, 2022	Quackery and Sharp Practices.	2 deaths, 5 Injured
22	2 Storey Building Under Construction	6th Avenue, Gwarimpa, Abuja	2nd February, 2023	Illegal addition of floor/violation of building plan approval, Sub-Standard Materials and Poor Workmanship.	3 Deaths, 19 Injured
23	4 Storey Hotel Building Under Construction	Plot 654, Dape (Near Berger Clinic), Life Camp, Abuja	3rd July, 2023	Use of sub-standard materials, violation of development control orders.	1 Death
24	2 Storey Building	Lagos Street, Opposite Garki Police Station, Garki Village, Abuja	23rd August, 2023	Torrential Rainfall- Triggered Collapse.	2 Deaths

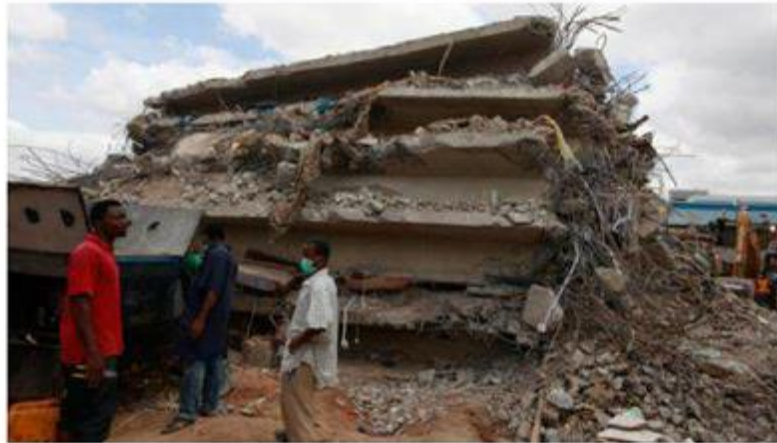
Plate 2: Multi-Storey Building Collapse in Gwarinpa, Abuja – 2nd February, 2023.
