INVESTIGATION OF THE MECHANICAL AND MICROSTRUCTURAL PROPERTIES OF WELDED API X70 PIPELINE STEEL

T. M. Ike, O. Adedipe, S. A. Lawal*, M. S. Abolarin and O. A. Olugboji

Department of Mechanical Engineering, Federal University of Technology, Minna, Nigeria

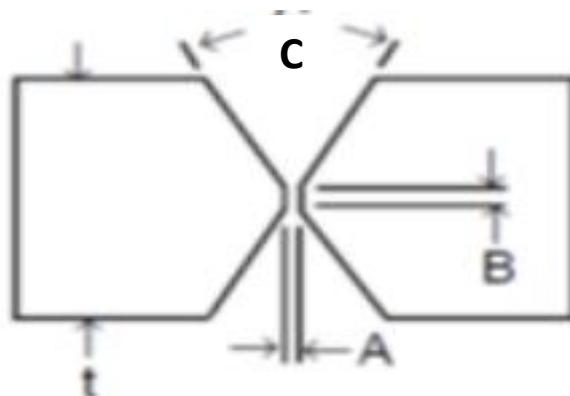
Figure 1: Diagram of weld joint prepared before welding specimen plates

where: t (plate thickness) = 20.8mm, A (Root opening) = 4mm, B (land thickness) = 2.4mm and C (groove angle) = 60°

The first task carried out in order to prepare the steel plate for welding was the removal of all the impurities such as rust and oxide by cleaning the edges using iron brush. A butt joint was prepared by using cutting technique and a double V joint preparation was adopted to make for easier welding with less metal weld and less distortion. The manual metal arc (MMA) welding technique, in flat welding positions (1G), was applied to fill the joints. A sketch of the typical joint prepared before the welding is as shown in Figure 1.

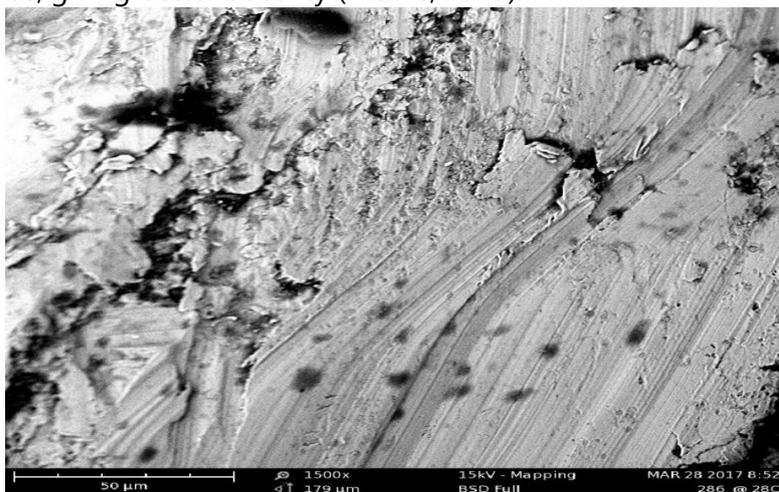
Figure 9: Microstructure of base metal in air (1,500X)

The micrograph obtained from base material through SEM is shown in Figure 9 where large grain sizes can be observed, and this depicts ductility. Basically, ductility is caused by the slip phenomenon of crystals and slip lines are confined to the grain boundaries. The finer the grain

sizes may be related to the lesser ductility. However, in case of larger grains, larger amounts of slip could occur thus, giving better ductility (Morris, 2013).

1. Large grain sizes were observed in the microstructure of the sample API X70 steel plate and that implied that the steel was ductile since large grains give room for large amounts of slip to occur thus giving better ductility. The API X70 steel base metal composed of manganese (0.51wt% Mn), iron (97.73 wt% Fe), in combination with very low carbon content (0.051 wt% C) and minor additions of alloying elements such as vanadium (0.021wt% V), molybdenum (0.118 wt% Mo), chromium (0.240 wt% Cr), copper (0.002 wt% Cu), and a carbon equivalent (CE IIW) of 0.38. The API X70 is therefore classified as low carbon steel with alloying elements (Mn, V, Cr, Si, Ni, Mo and Cu) that help in the strengthening of the ferrite

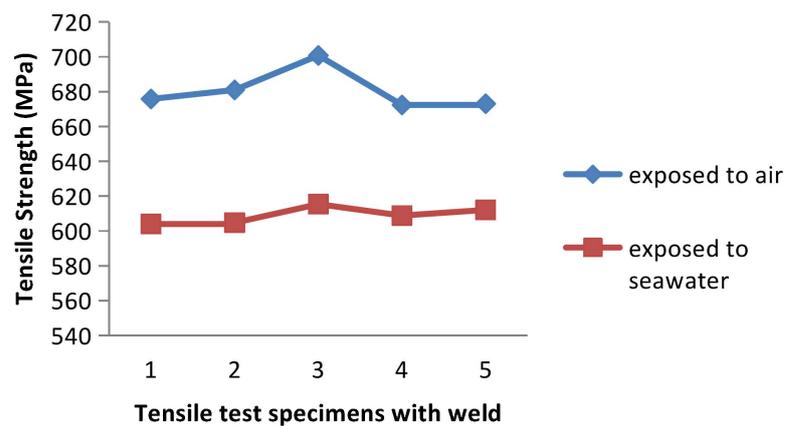
Figure 10: Tensile strength for tensile test specimens with weld joints

Five tensile test results for welded joints exposed to air and seawater respectively were recorded and plotted as shown on Figure 10. It was observed that the tensile strength of the welds reduced after exposure to seawater environment for 12 weeks. The average tensile strength of the samples that were exposed to seawater was found to be 609.154 MPa, while for those exposed to air was 680.624 MPa. The percentage reduction in tensile strength was found to be 10.5%, which implies that the corrosive activity of the seawater would be revealed irrespective of the exposure time as mentioned previously. However, it must be mentioned that investigation of mechanical properties of the unwelded samples is beyond the scope of this paper.

2. The average tensile strengths for welded joints exposed to air and seawater for 12 weeks were 680.624MPa and 609.154MPa respectively while the average compressive strengths for welded joints exposed to air and seawater for 12 weeks were 1500.02MPa and 150.75MPa respectively. At the temperature of zero degrees Celsius and same exposure period, the Charpy impact energy absorbed by welded joint exposed to air was 150.7J while that absorbed by welded joints exposed to seawater was 80.3J.

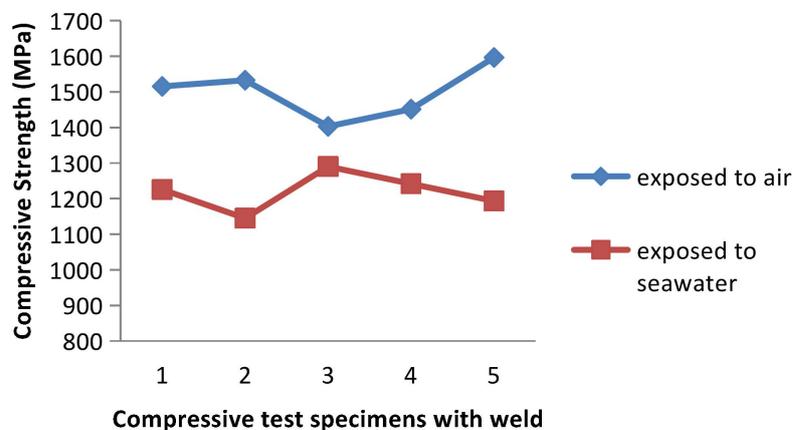
Figure 11: Compressive strength for compressive test specimens with weld joints

Figure 11 shows that the compressive strength of all five compressive test samples with welded joint were reduced after immersion into seawater environment for 12 weeks. The average compressive strength of the samples exposed to seawater was 1209.34 MPa, while those exposed to air was found to be 1480.68 MPa. The percentage reduction in compressive strength was determined to be 18.7%, which implies that the effect of soaking time was significant in compressive test samples than in samples used for tensile tests.

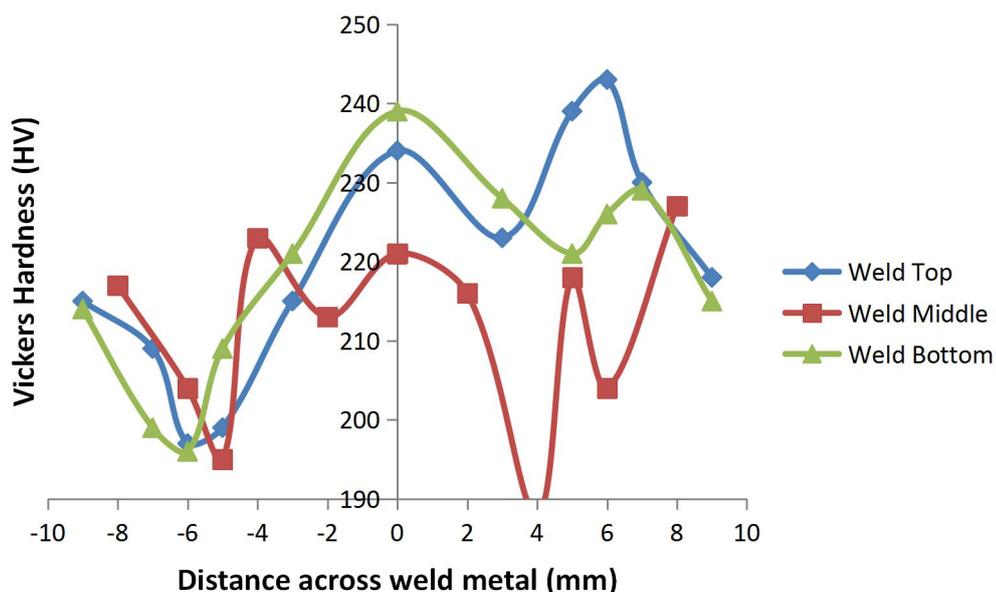
Figure 12: Hardness profile as a function distance from the center of weld bead

The hardness test results are shown on Table 3 while Figure 12 depicted the hardness profile across the weld top surface. From Table 3 the Weld has a higher average hardness value of 223.8 HV compare to HAZ which has an average value of 214.5 HV as well as the parent metal with an average value of 217.3 HV. These results obtained are in agreement with the work done by Omale et al. (2017). The variations in the hardness across the weld may be attributed to several factors such as residual stresses developed just after welding. From the microstructural point of view, the high hardness in the weld may be attributed to the fine grain size, and the interlocking

nature of the ferrite grains (Loureiro, 2002). One of the factors contributing to lower hardness in the HAZ is high heat input below its melting point and hence retention of heat in this region. The lower hardness in the HAZ might be explained by the intense grain growth in this region resulting from high heat input below its melting point (Kacar and KöKemli, 2005)

3. The hardness profile of welded joints showed variations in hardness across the base metal, HAZ and weld metal whereby the weld metal had the highest value of hardness (223.8HV) followed by the base metal (217.3HV) and the HAZ had the least (214.5HV).
4. The mechanical properties of the welds are compromised by exposure to corrosive environment such as seawater as observed in the results obtained from tensile, compressive, and Charpy test experiments. The results showed 10.5% reduction in the tensile strength, 18.7% reduction in compressive strength and at least 37% decrease in impact energy absorbed by the welds after exposure to seawater for 12 weeks.

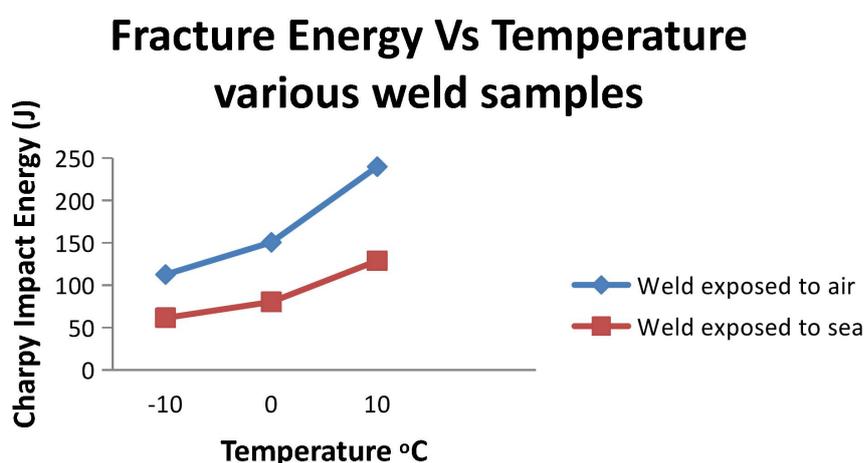
Figure 13: Fracture energy (J) and Temperature (°C)

The test results are shown in Table 4 and represented in Figure 13, it can be observed that the impact energy of the weld samples exposed to air is higher than the impact energy of the weld samples exposed to sea water at all the temperatures used. The lower impact energy observed for weld samples exposed to seawater was due to the corrosive environment which affected the microstructure of the weld. The test results also confirm the work done by Nakano et al, (1993), concerning corrosion fatigue crack propagation behaviour of TMCP steels.

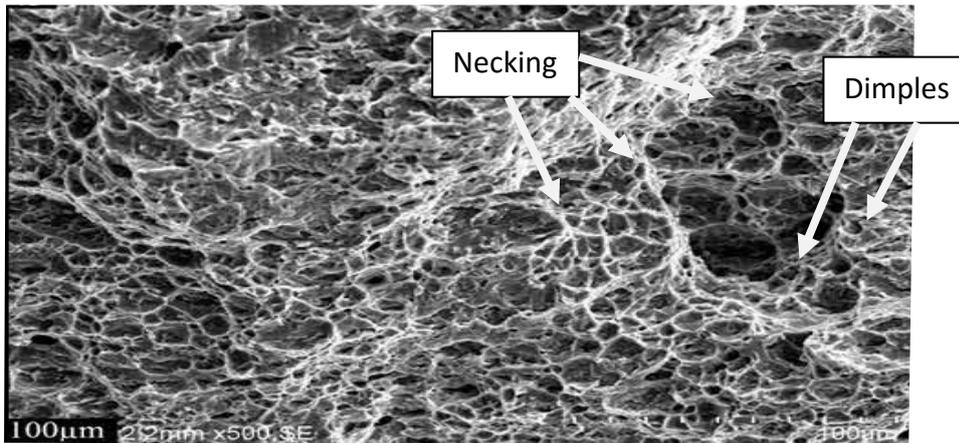
Figure 14a: SEM images of the fracture surfaces of weld Charpy test specimen

Figures 14(a-b) show SEM images of the fracture surfaces of X70 steel Charpy test specimens with welded joints. The fracture surface morphology of the specimen without exposure to corrosive environment was 100% ductile with numerous fine dimples in the fracture surface which is considered a sign of ductile fracture as shown in Figure 14a. Moreover, a considerable amount of necking was observed during deformation. After exposure to seawater for three months the fracture surface was still predominantly ductile and shows evidence of dimples. This specimen also shows some necking during deformation as shown in Figure 14b. It means that if the specimen were exposed for a longer time, it would eventually show the characteristics of completely brittle failure.
