PERFORMANCE AND ECONOMIC ANALYSIS OF KAINJI HYDROPOWER PLANT IN NIGERIA

In this study, performance and economic evaluation of Kainji Hydropower Station in Nigeria from 2008 to 2017 was carried out. Data including total energy generated (MWh), station service consumption (MWh), total energy sent out to the grid (MWh), average inflow rate (m^3/s) and average gross operating head (m) were obtained from the efficiency department of the Hydropower station from the year 2008 to 2017. Mathematical models were used based on some key parameters which include: Capacity Factor, Plant Use Factor, Availability, Power Generated and Economic Cost of Outages and Operations. The result reveals that the average power generated within the period under review was 363.53MW, with a maximum of 476.95MW in 2010 and 292.44MW in 2014 as against the installed capacity of 760MW. The Capacity Factor of the plant was between 11.04% (2014) and 40.51% (2008) as against industry best practice of between 50% to 80%. The Plant Use Factor ranged between 38.48% in 2014 to 62.76% in 2010 as against acceptable value of 95% and above, while the plant availability hovers between 28.69% in 2015 and 91.26% in 2009 as again

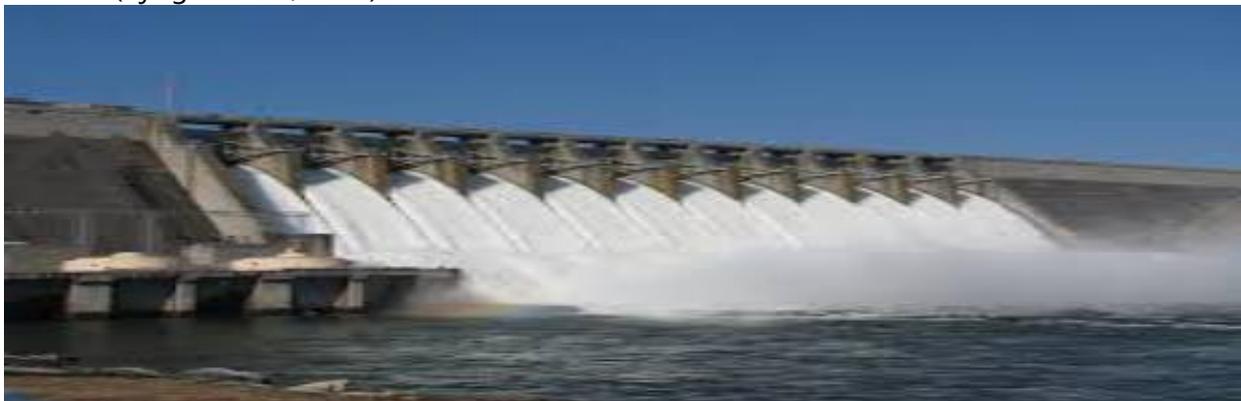
Figure 1: Side View of Kainji Hydropower Dam (Adegboyega and Famoriji, 2013)

Kainji Hydropower Station is the oldest Hydropower plant in Nigeria. Figure 1 shows the side view of the Hydropower dam. Kainji Dam is a dam across the Niger River in Niger state of Northern Nigeria (Madu, 2018). Construction of the dam was carried out by an Italian Civil Engineering Company in 1964 and was completed in 1968. The cost of the dam was estimated at \$209 million, with one-quarter of this amount used to resettle the displaced people by the construction of the dam (Madu, 2018). The dam was designed to have a generating capacity of 960MW, however, only 8 of its 12 turbines have been installed, making the installed capacity to 760MW (Ajeigbe et al., 2013).

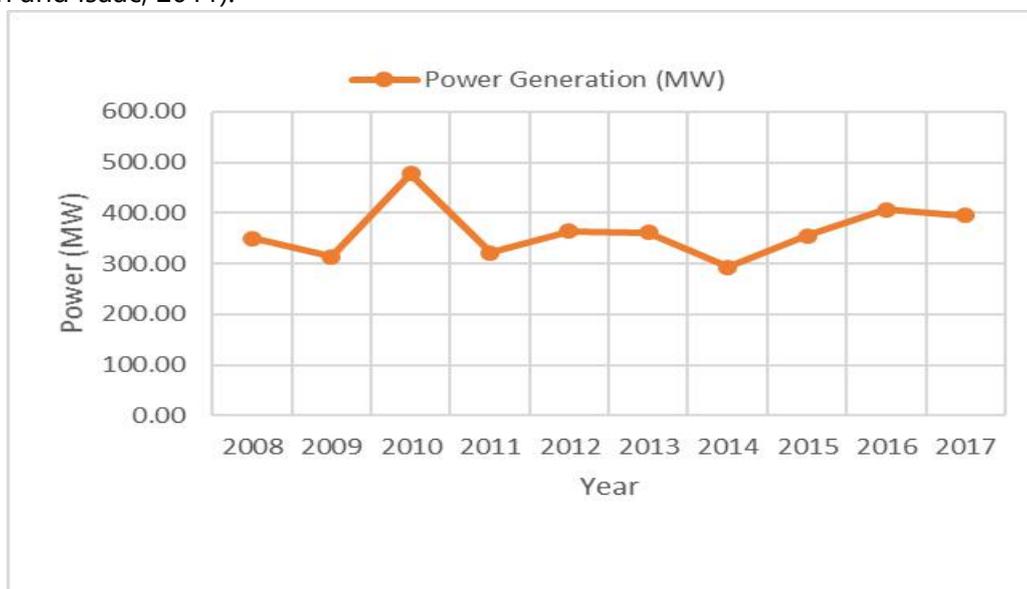
Figure 2: Power Generation from 2008-2017

The plant full load installed capacity is 760MW, however, Table 2 showed that the generated power for the period under review ranges from 292.44MW to 476.95MW. A graphical illustration depicting how the generated power varies the selected years under review was as shown in Figure 2. This indicates a significant gap between installed capacity and actual power generated per year, which may be due to ageing equipment, seasonal variation in the volume of water coupled with poor maintenance culture. Also, for the period under review, this short fall in generation ranges from 61.5% to 37.2%, which is against acceptable values of from 5% to 10% (Obodeh and Isaac, 2011).

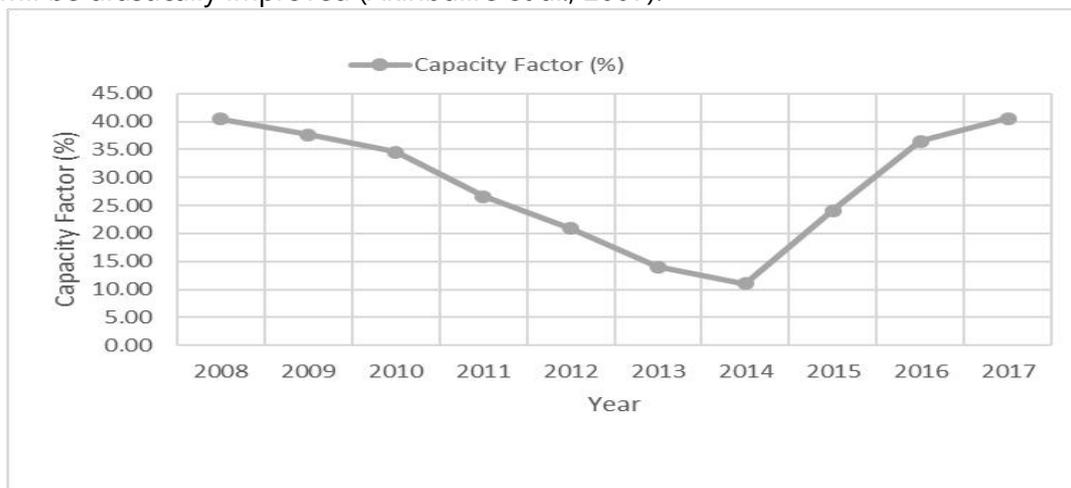
Figure 3: Capacity Factor from 2008-2017

The plant CF ranged from 11.04% to 40.51% for the period under review as shown in Figure 3. This is as against industrial best practice of from 50% to 80% (Oyedepo et al., 2015). Low value of CF is an indication of low energy generation and by economic implication, the accrued revenue will be appreciably less than operational cost. Notable among other factors that can be held accountable for low value of CF is recurrent plant failure; frequent plant failure most often caused under-utilization of the plant for major part of the year (Ekeh, 2008). It needs to be reiterated that high CF is beneficial and desirable for economic operation of the power plant and

to sustain high CF value, scheduled routine maintenance should be encouraged, this will in no doubt reduce if not eliminate the occurrence of recurrent plant failure. Consequently, the above trend will be drastically improved (Akinbulire et al., 2007).

value of plant. The study revealed that for the period under review, the capacity factor ranges from 11.04% (2014) to 40.51% (2017) as against the acceptable value of 50%-80%. The plant use factor also ranges from 38.48% (2014) to 62.76% (2010) as against accepted value of 95% and above. Again, the availability of the plant ranges from 28.69% (2014) to 91.26% (2009), also against international best practices of 99.99%.

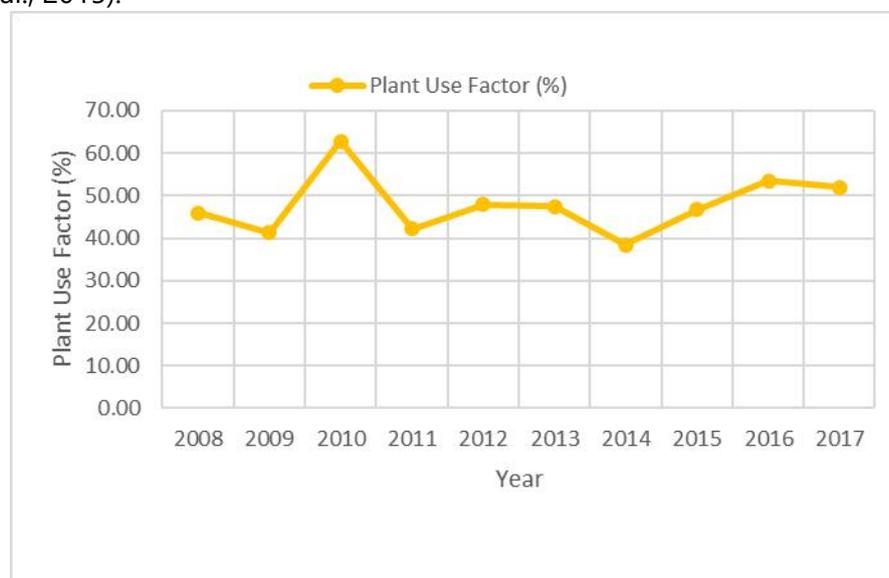
Figure 4: Plant Use Factor from 2008-2017

Presented in Figure 4 is the plot of PUF values obtained against the reviewed years, it was observed that PUF ranges between 38.48% in 2014 to 62.76% in 2010, these values are comparatively lower as measured to the international standard of over 95% for hydropower station (Oyedepo et al., 2015). PUF indicates how the plant is well managed in terms of downtime. The ranges of the PUF for the period under review shows huge downtime which can be attributed to excessive plant failures most often caused by poor maintenance culture (Oyedepo et al., 2015).

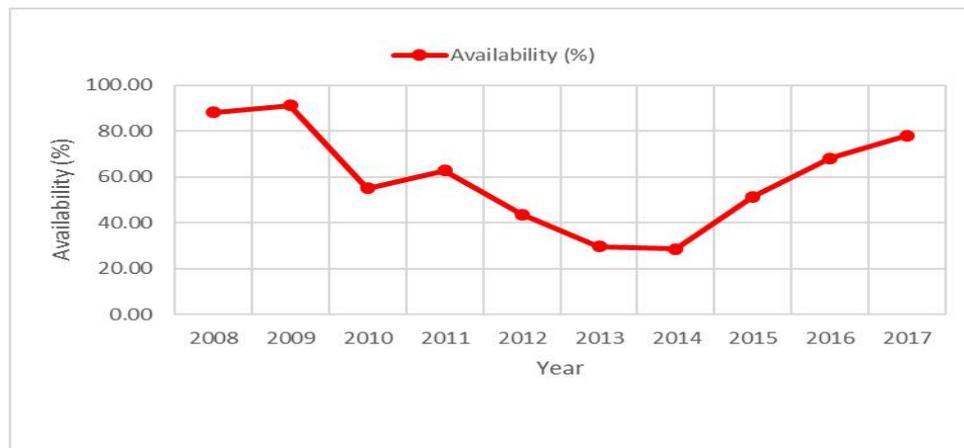
Figure 5: Availability of Plant from 2008-2017

Figure 5 shows the plant availability for the period under review (2008-2017). It was found that the plant availability ranges from 28.69% in 2015 to 91.26% in 2009. These values of availabilities are against the recommended standard of 99.99% (Oyedepo et al., 2015). The poor plant availability is as a result of huge downtime which can be significantly improved upon by proper routine maintenance and personnel training on technical know-how knowledge (Chris et al., 2017).

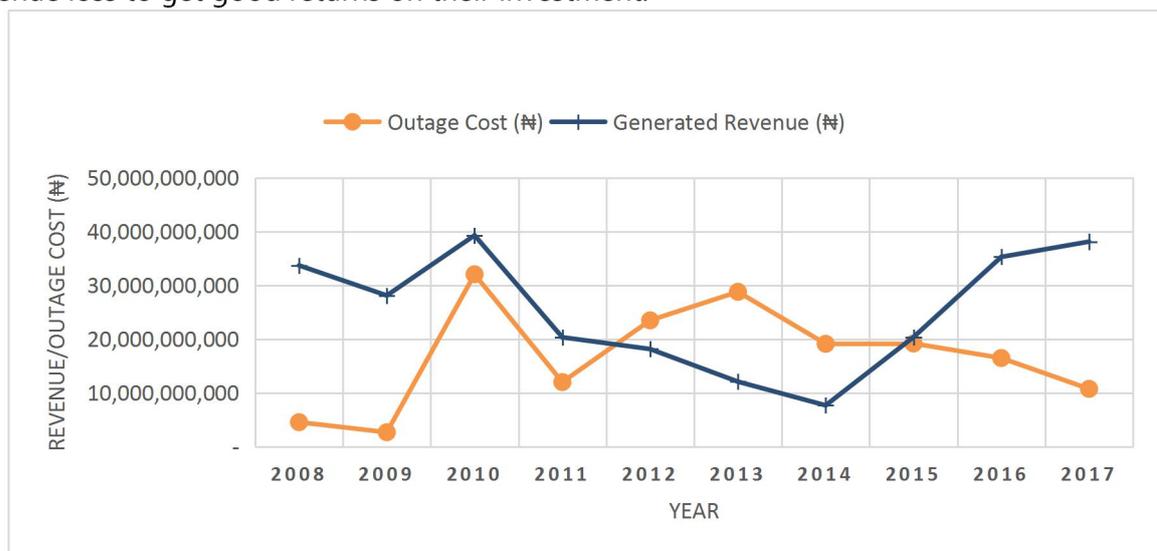
Figure 6: Cost Analysis of Plant

Figure 6 shows the plant revenue loss and revenue generated from 2008-2017. The result revealed for the period under review, the total revenue generated was ₦253,116,672,716, while the total revenue loss due to system downtime was ₦169,134,293,297. The revenue loss is about 66.82% of revenue generated which is by no means a huge amount. The management of the power station should embark on routine preventive maintenance in order to mitigate this huge revenue loss to get good returns on their investment.

Furthermore, the study revealed that for the period under review, the plant cost of outage due to system downtime was ₦169,134,293,297, which is about 66.82% of revenue generated. The analysis carried out showed that the value obtained for the all the performance metrics revealed the deplorable state of the power station and as a matter of concern, the economic operation of the power station is far behind the standard. This is by no means a small value and an eye opener for the authorities concerned to do more by investing in the power plant in order to get good return on investment.
